REPORT NO. 96-18

WIDE AREA MUNITION (WAM)
PALLET MIL-STD-1660 AND
RAIL IMPACT TESTS

WIDE AREA MUNITION (WAM) PALLET MIL-STD-1660 AND RAIL IMPACT TESTS

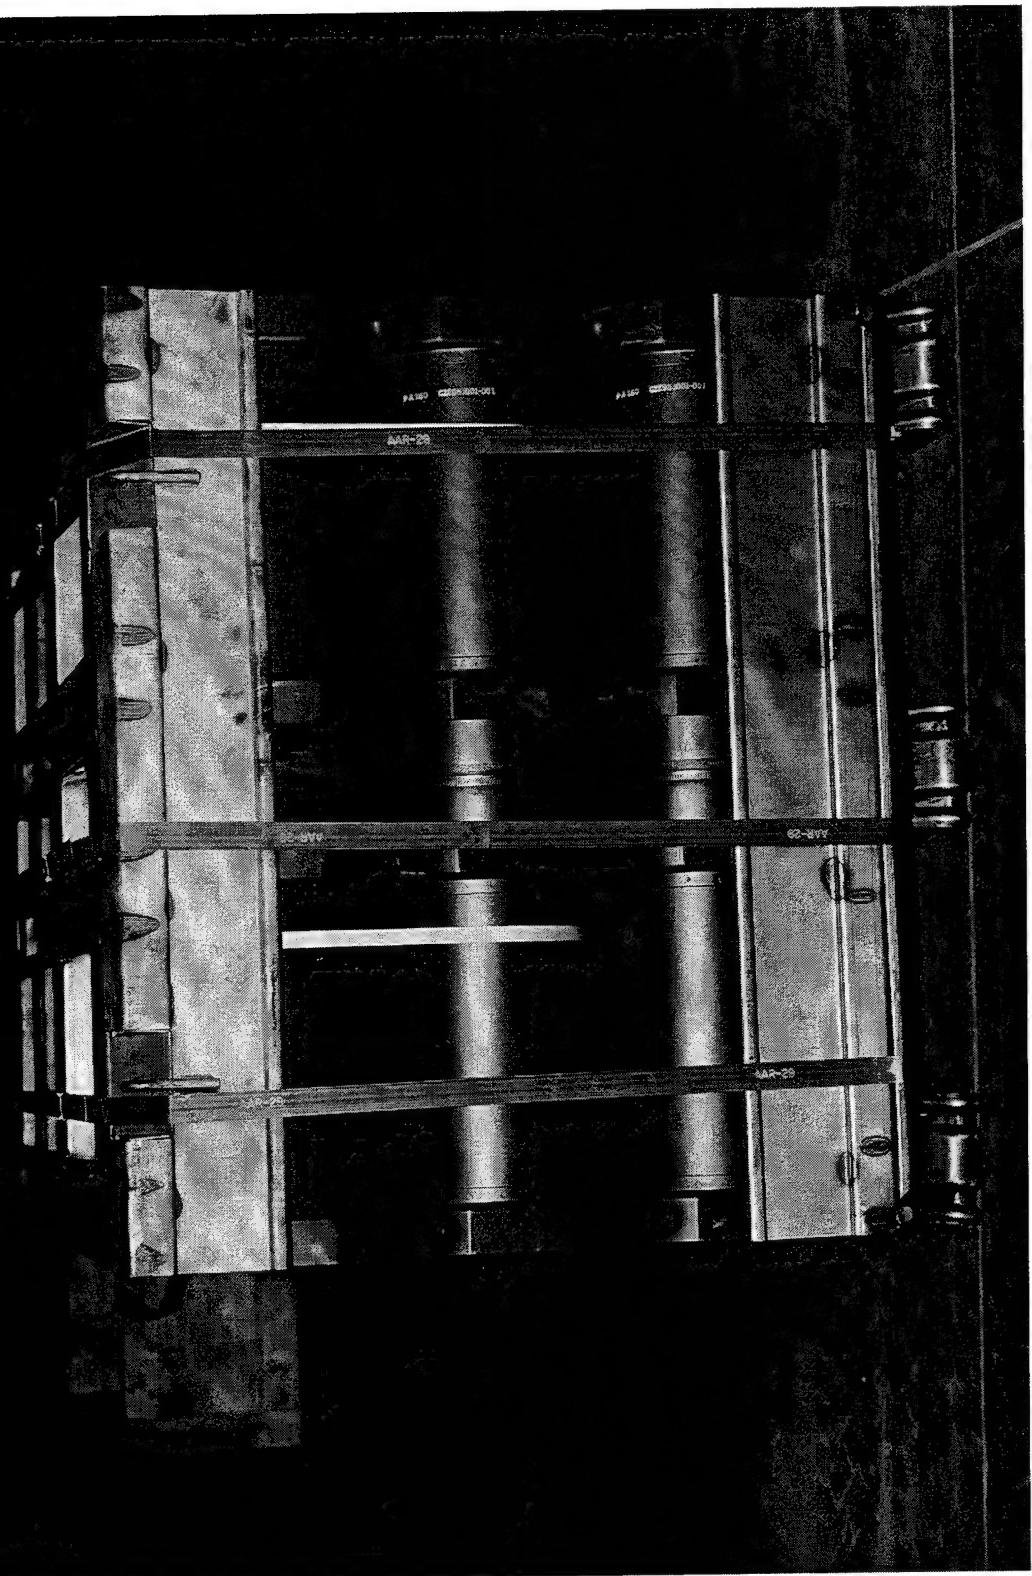
PHOTO NO. A0317-SCN-96-105-2207. This photo shows the WAM pallet unitized load after completion of
MIL-STD-1660 tests.

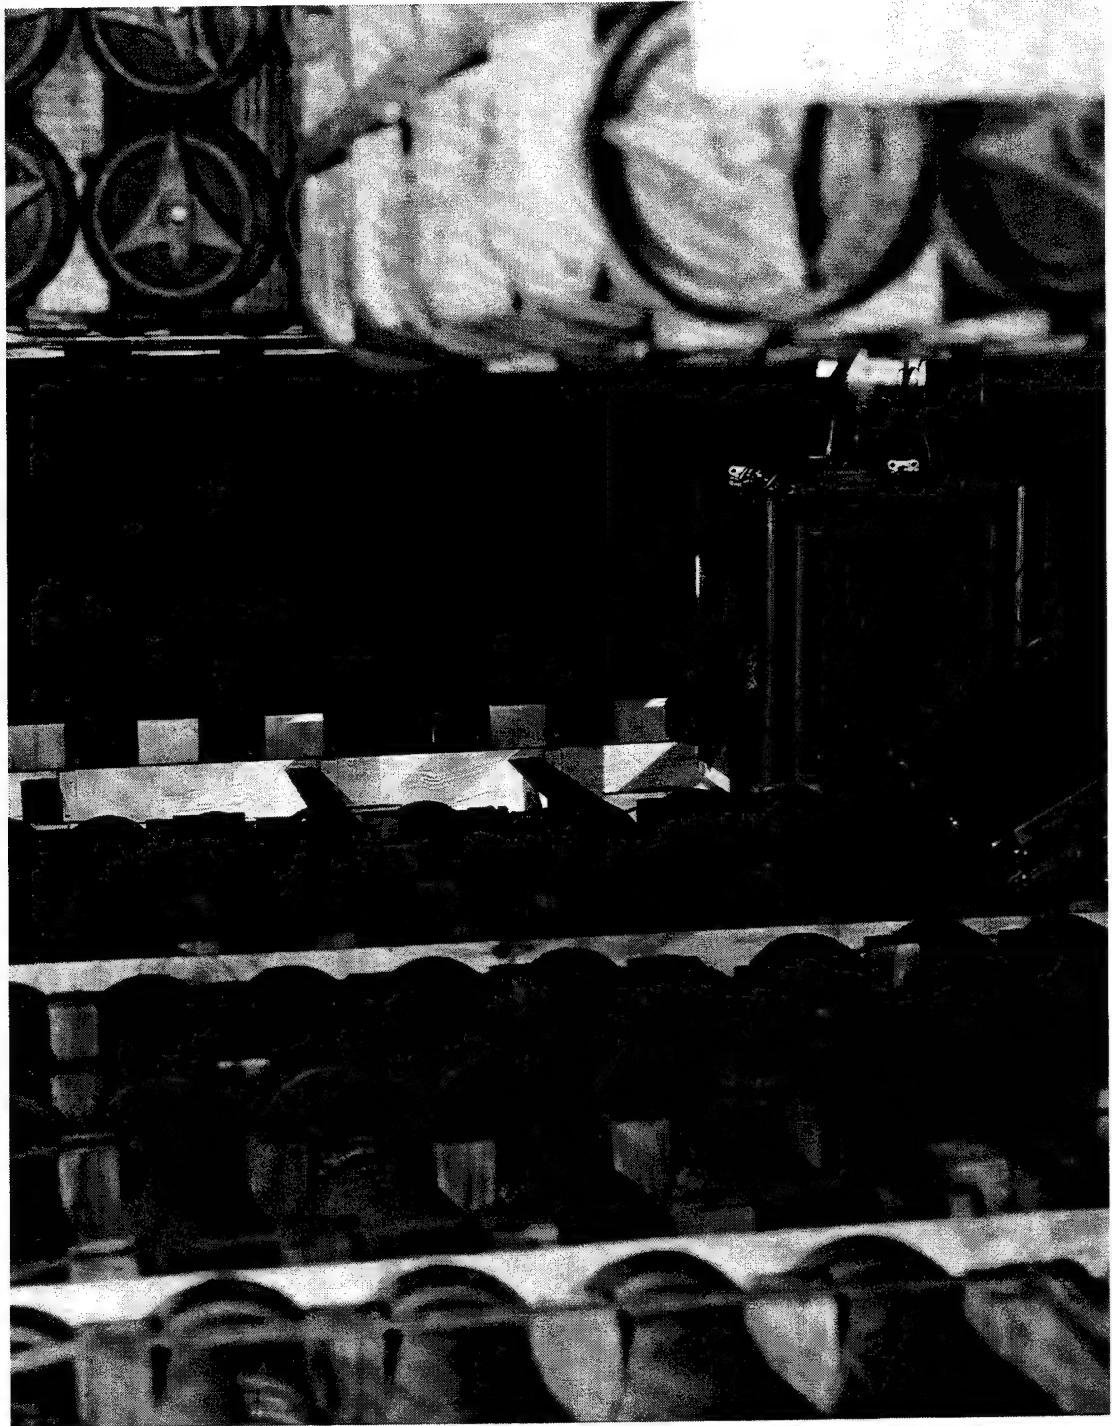
PHOTO NO. A0317-SCN-96-106-2241. This photo shows the loaded boxcar during the rail impact test.

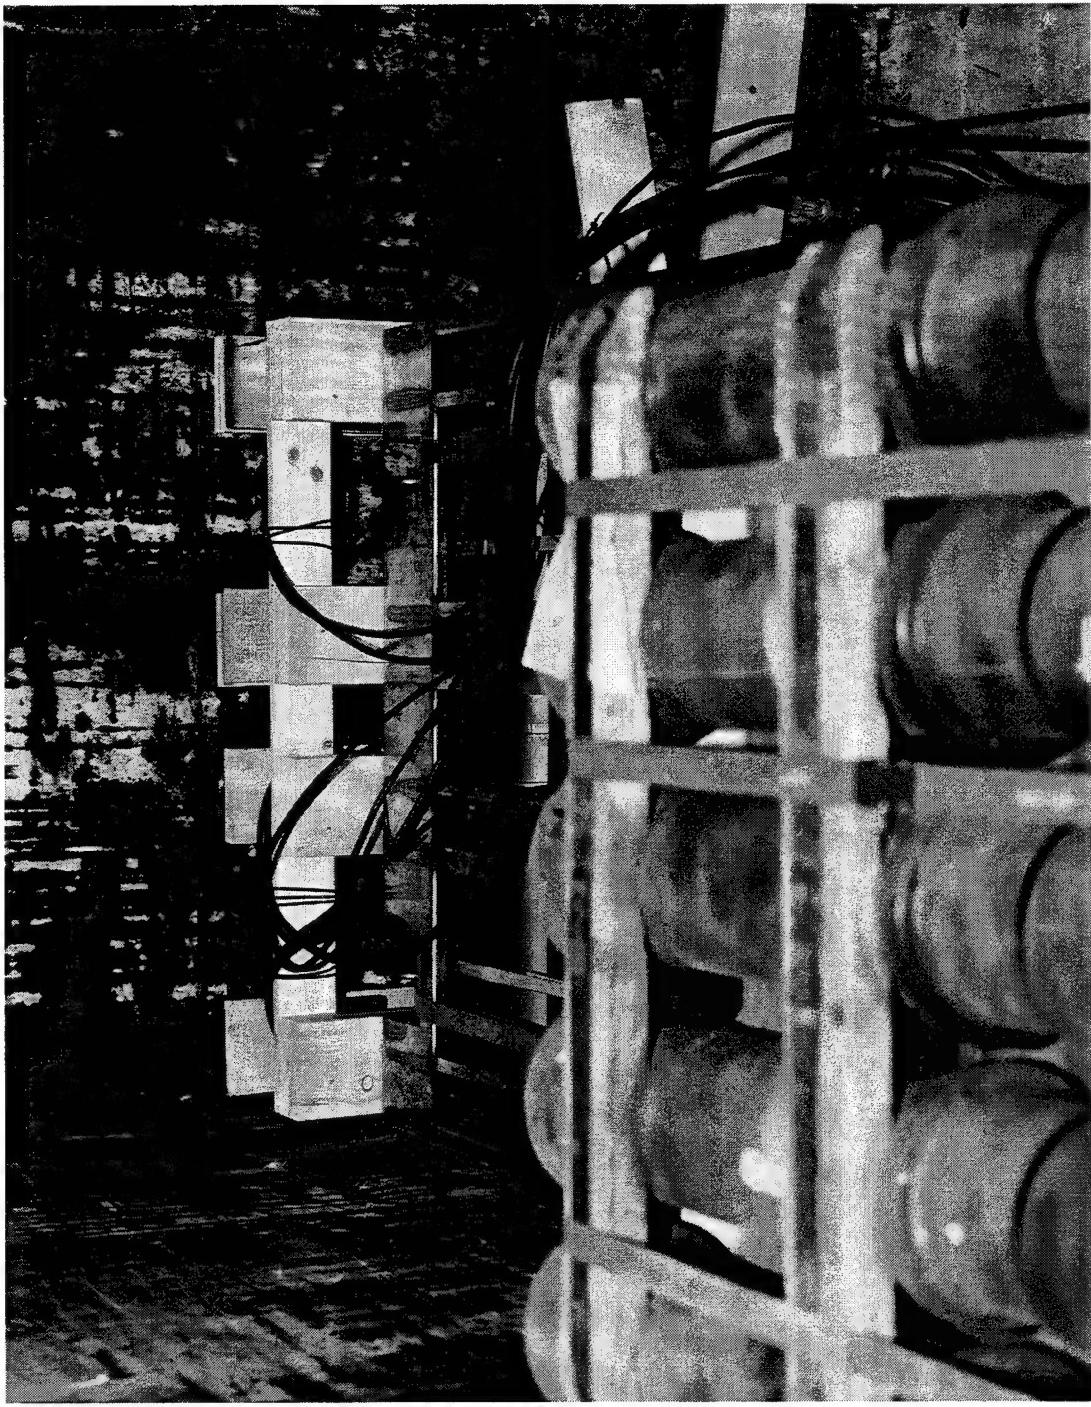
PHOTO NO. A0317-SCN-96-105-2195. This photo shows an inside view of the railcar with the full test load. The two test pallets are located at either end of the row on the right, while the other inert loads are palletized 155mm propelling charge containers. Note the portable data acquisition system in the center aisle used to collect data from the load cells.

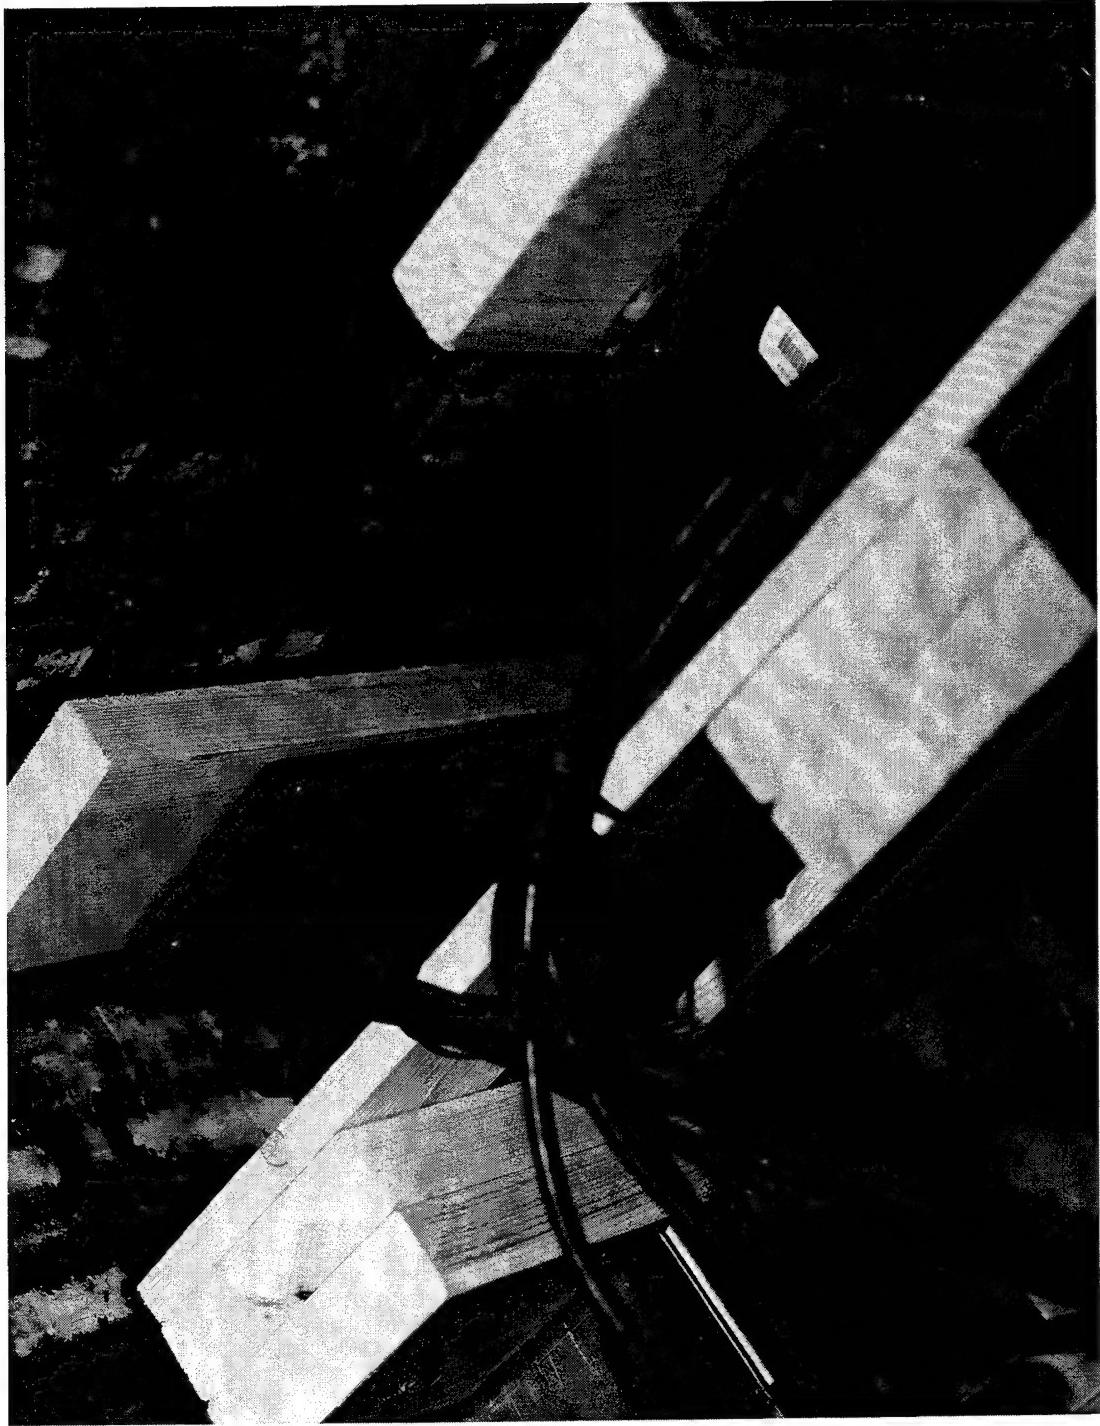
PHOTO NO. A0317-SCN-96-105-2199. This photo shows the WAM pallet loaded against the end wall of the boxcar. Notice the wood dunnage between the test pallet and the wall, which contains the load cells.
